PERFORMANCE TEST REPORT

BERRIDGE MANUFACTURING COMPANY

SERIES/MODEL: Berridge Deep Deck Panels PRODUCT TYPE: Steel Roof Panels

Report No.: A0977.01-801-44
Test Date: 05/17/10
Through: 09/09/10
Report Date: 09/13/10
Expiration Date: 09/09/14

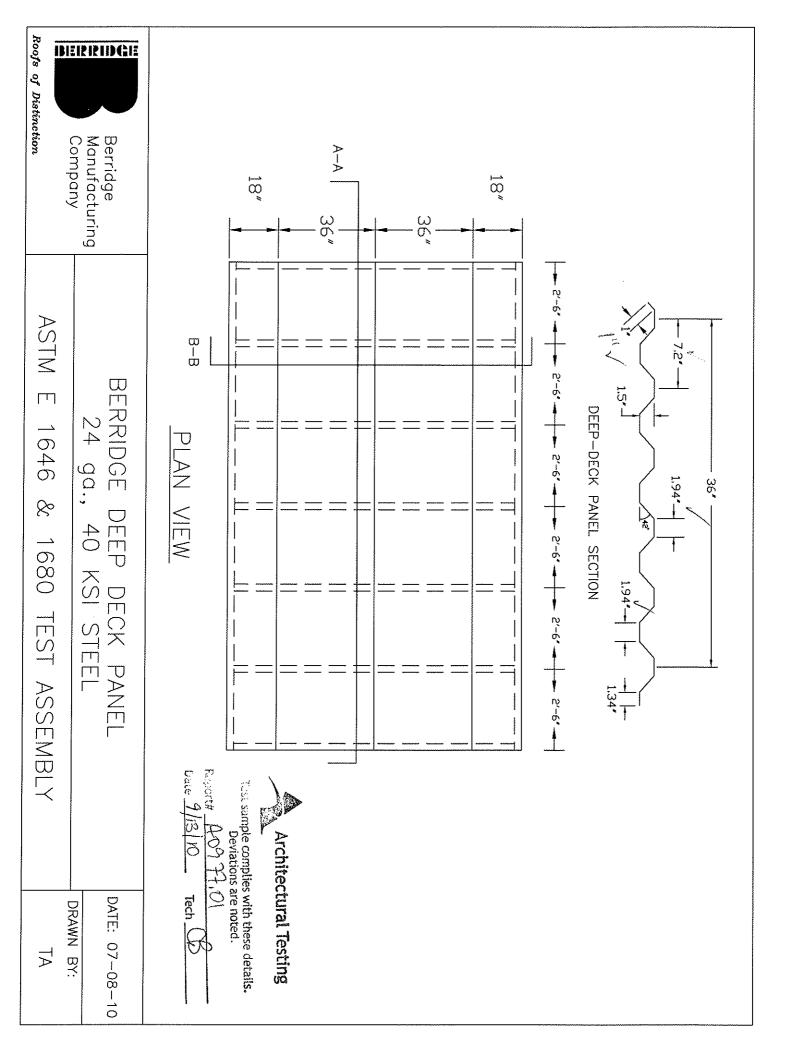
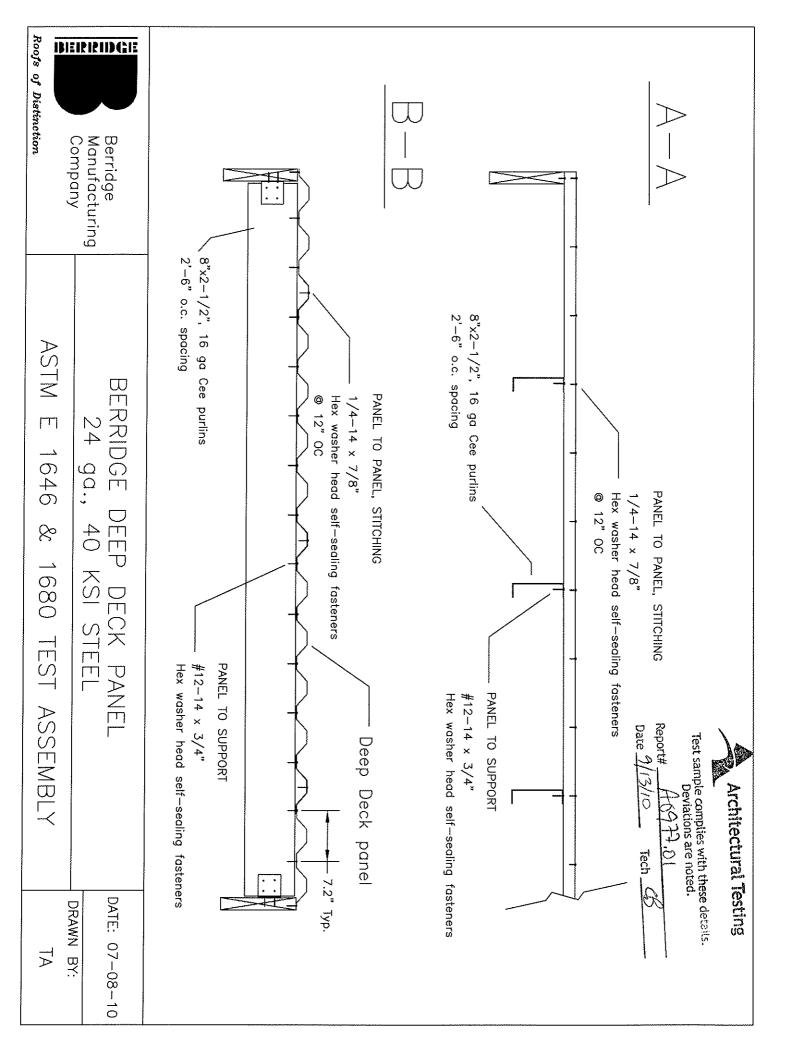
Drawing Reference: The test specimen drawings have been reviewed by Architectural Testing and are representative of the test specimen reported herein.
